**SEASONAL MONITORING PROGRAM  
DISMANTLE REPORT  
SITE 063042, LODI, CALIFORNIA.**

**January 1997**

**NICHOLS  
CONSULTING  
ENGINEERS, Chtd.**

TO: Mr. Aramis Lopez, Jr.  
Long-Term Pavement Performance Division  
FROM: Srikanth S. Holikatti and Douglas J. Frith  
DATE: January 31, 1997  
SUBJECT: **Suspension of SMP Site Monitoring Activities, Site 063042.**

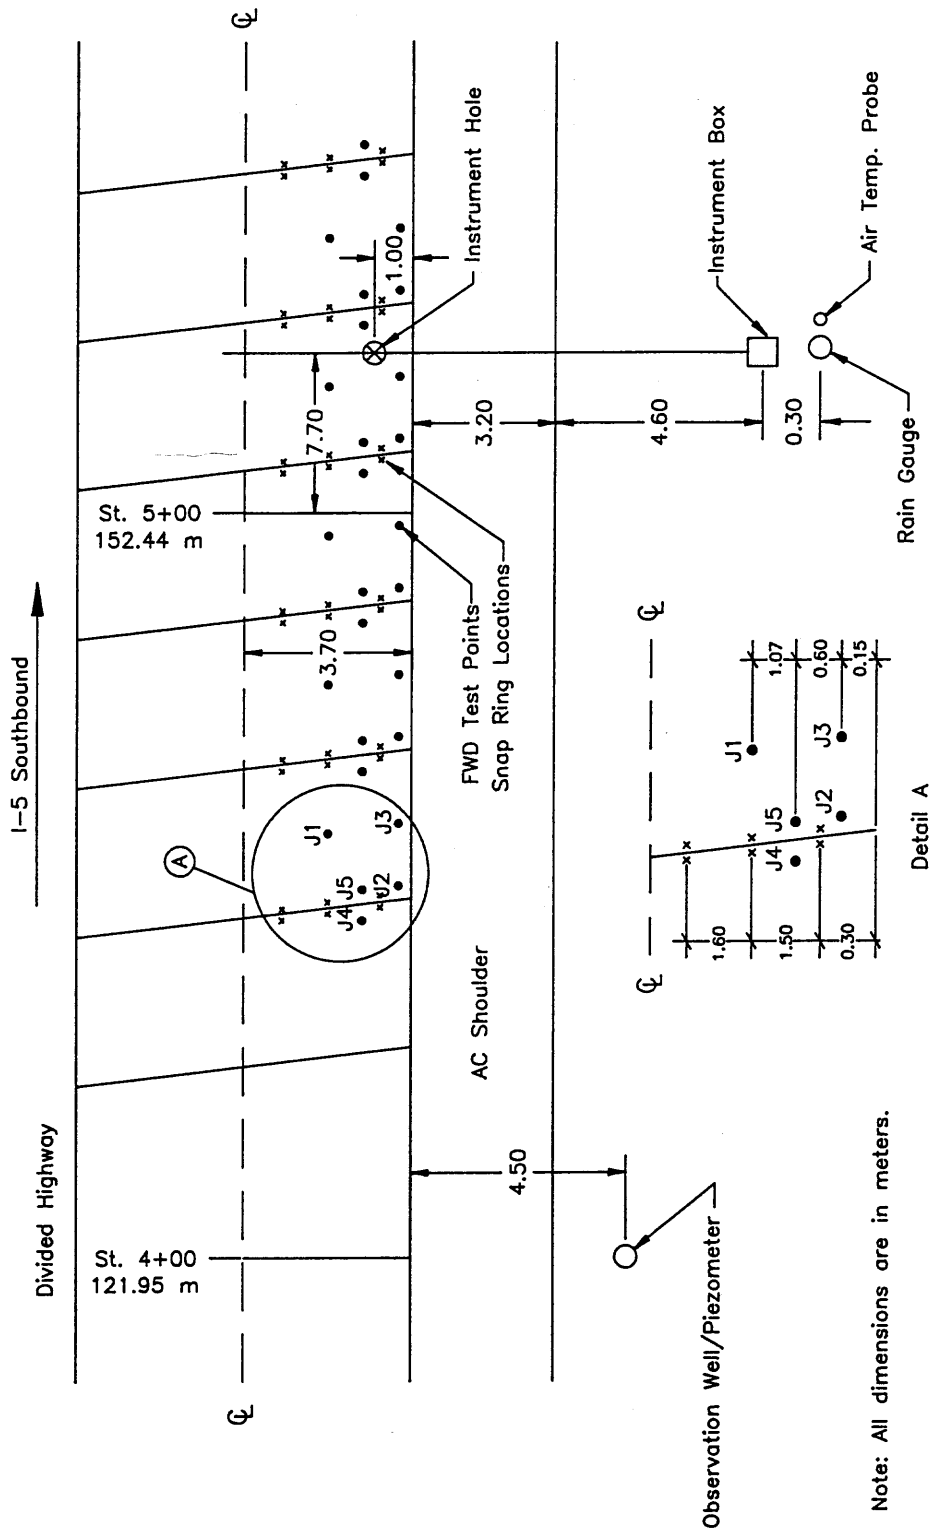
SECTION 063042  
Lodi, CA

The instrumentation hole is located in the outside lane, a distance of 160.14m (section station 5.00+25' 3"), from the section beginning, in the outer wheel path. The equipment cabinet is located 7.8m to the right of the lane edge and the pole is 0.3m behind the equipment cabinet. The observation well/piezometer is located at a distance of 121.95m from the start of the section., 4.5m away from the lane edge. Please refer to the site layout schematic for the testing and monitoring locations within the test section.

Note: All dimensions are in meters.

- A layout sketch of the section indicating the locations of the instrumentation hole, observation well, equipment cabinet, joint opening measurement snap rings, FWD test points and elevation measurement points was drawn so that, the site can be re-established easily upon return.

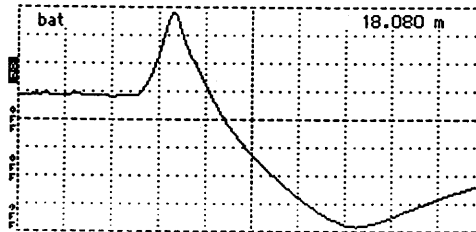
Tektronix 1502B TDR  
 Date 8/26/96  
 Cable #1 063042  
 Notes Looks Good

Cursor ..... 18.080 m  
 Distance/Div..... .25 m/div  
 Vertical Scale.... 57.7 m $\mu$ /div  
 VP ..... 0.99  
 Noise Filter..... 1 avs  
 Power ..... bat/low

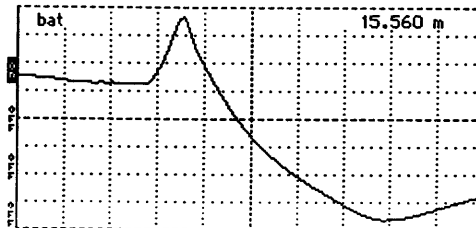
Tektronix 1502B TDR  
 Date 8/26/96  
 Cable #2 063042  
 Notes Looks Good

Cursor ..... 15.560 m  
 Distance/Div..... .25 m/div  
 Vertical Scale.... 64.8 m $\mu$ /div  
 VP ..... 0.99  
 Noise Filter..... 1 avs  
 Power ..... bat/low

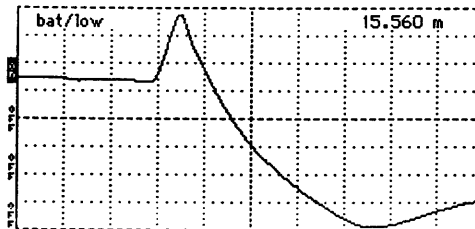
Tektronix 1502B TDR  
 Date 8/26/96  
 Cable #3 063042  
 Notes Looks Good

Cursor ..... 15.560 m  
 Distance/Div..... .25 m/div  
 Vertical Scale.... 59.4 m $\mu$ /div  
 VP ..... 0.99  
 Noise Filter..... 1 avs  
 Power ..... bat/low

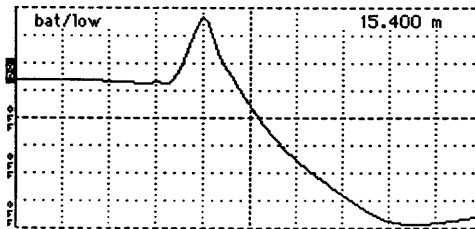
Tektronix 1502B TDR  
 Date 8/26/96  
 Cable #4 063042  
 Notes Looks Good

Cursor ..... 15.400 m  
 Distance/Div..... .25 m/div  
 Vertical Scale.... 66.7 m $\mu$ /div  
 VP ..... 0.99  
 Noise Filter..... 1 avs  
 Power ..... bat/low

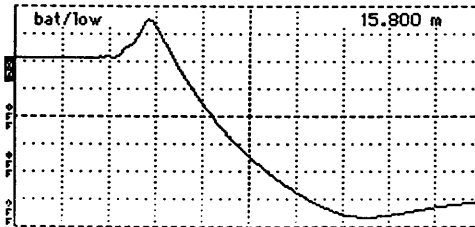
Tektronix 1502B TDR  
 Date 8/26/96  
 Cable #5 063042  
 Notes Looks Good

Cursor ..... 15.800 m  
 Distance/Div..... .25 m/div  
 Vertical Scale.... 59.4 m $\mu$ /div  
 VP ..... 0.99  
 Noise Filter..... 1 avs  
 Power ..... bat/low

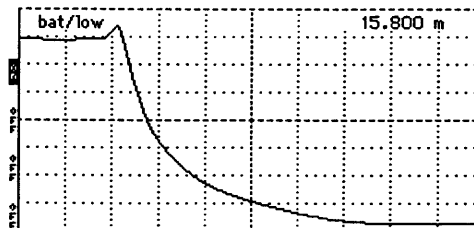
Tektronix 1502B TDR  
 Date 8/26/96  
 Cable #6 063042  
 Notes Hard looking  
Endo

Cursor ..... 15.800 m  
 Distance/Div ..... .25 m/div  
 Vertical Scale.... 79.2 mP/div  
 VP ..... 0.99  
 Noise Filter..... 1 avg  
 Power..... bat/low

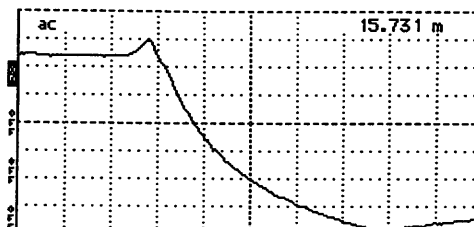
Tektronix 1502B TDR  
 Date 8/26/96  
 Cable #7 063042  
 Notes Looks Good

Cursor ..... 15.731 m  
 Distance/Div ..... .25 m/div  
 Vertical Scale.... 64.8 mP/div  
 VP ..... 0.99  
 Noise Filter..... 1 avg  
 Power..... ac

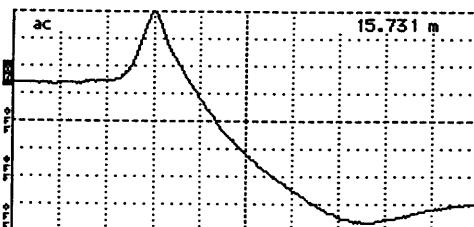
Tektronix 1502B TDR  
 Date 8/26/96  
 Cable #8 063042  
 Notes Looks Good

Cursor ..... 15.731 m  
 Distance/Div ..... .25 m/div  
 Vertical Scale.... 64.8 mP/div  
 VP ..... 0.99  
 Noise Filter..... 1 avg  
 Power..... ac

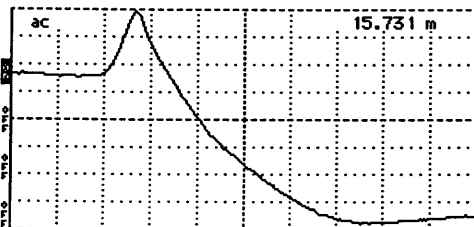
Tektronix 1502B TDR  
 Date 8/26/96  
 Cable #9 063042  
 Notes Looks Good

Cursor ..... 15.731 m  
 Distance/Div ..... .25 m/div  
 Vertical Scale.... 70.6 mP/div  
 VP ..... 0.99  
 Noise Filter..... 1 avg  
 Power..... ac

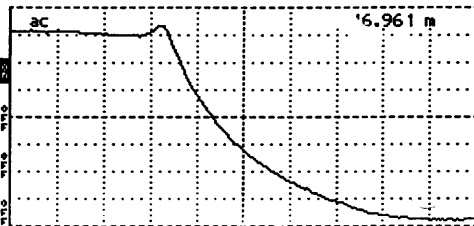
Tektronix 1502B TDR  
 Date 8/26/96  
 Cable #10 063042  
 Notes Maybe Nipper  
Looking Endo

Cursor ..... 16.961 m  
 Distance/Div ..... .25 m/div  
 Vertical Scale.... 64.8 mP/div  
 VP ..... 0.99  
 Noise Filter..... 1 avg  
 Power..... ac

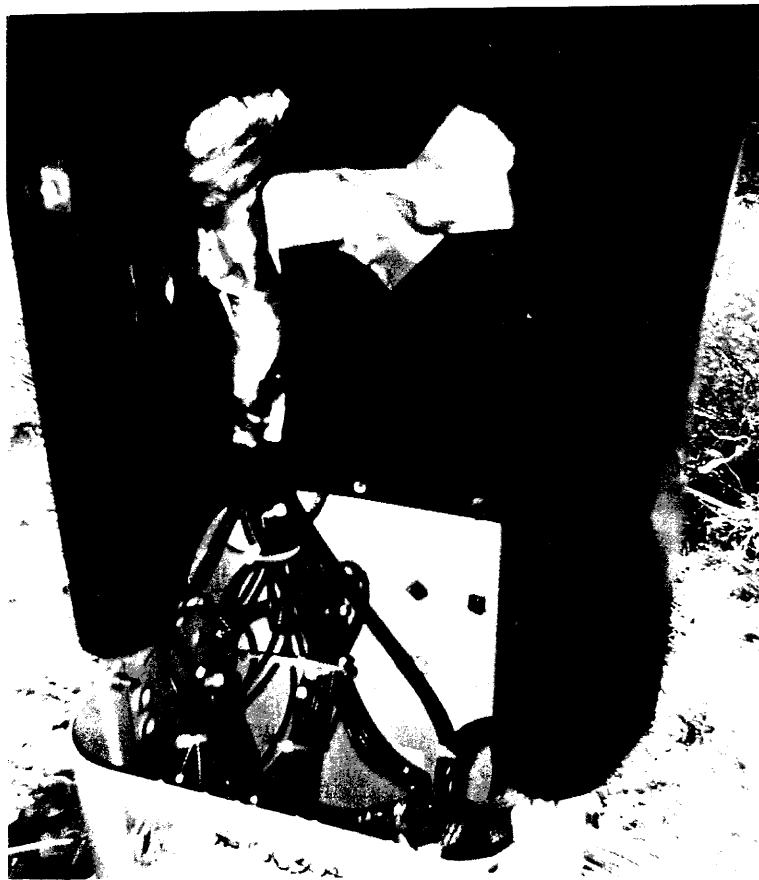
Taped Cable-ends.

- A coat of electronics grade anti-corrosive compound was applied to the cables and wiring connections to protect against corrosion of contact points. The cables were then put in a heavy duty plastic bag and were taped to keep out the elements. They were then secured inside the equipment cabinet.

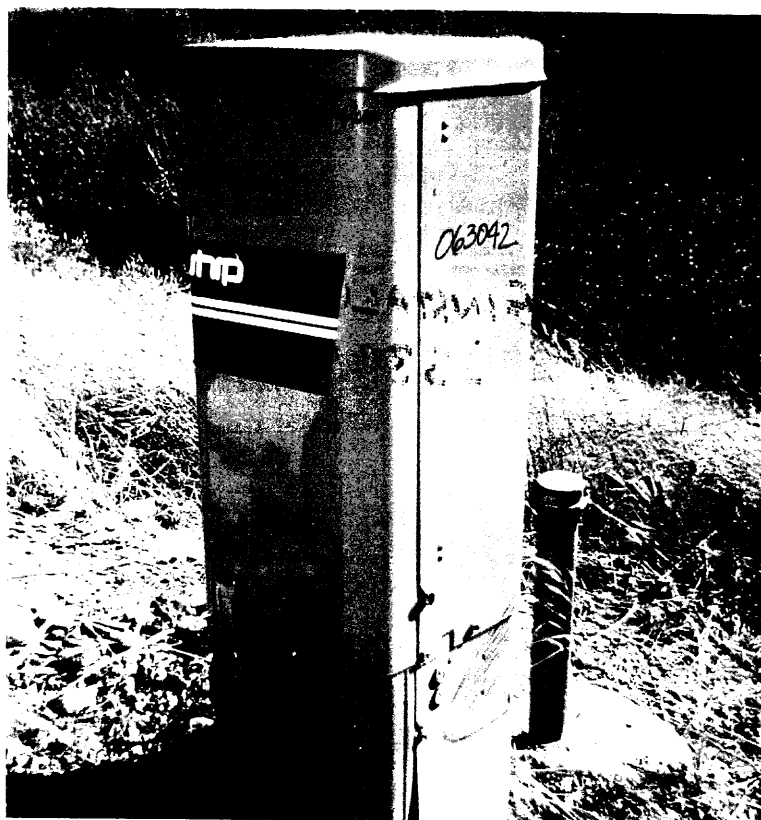
Equipment Cabinet.

- The instrument panel board containing the CR10 datalogger, the relay and the terminal strip was removed.
- The equipment cabinet was checked and adequate drainage was ensured in case of heavy precipitation.

- The equipment cabinet lock was lubricated with graphite lubricant, the lock was taped to keep out the natural elements.
- The deflection and elevation measurement locations were marked with white paint for easy identification.

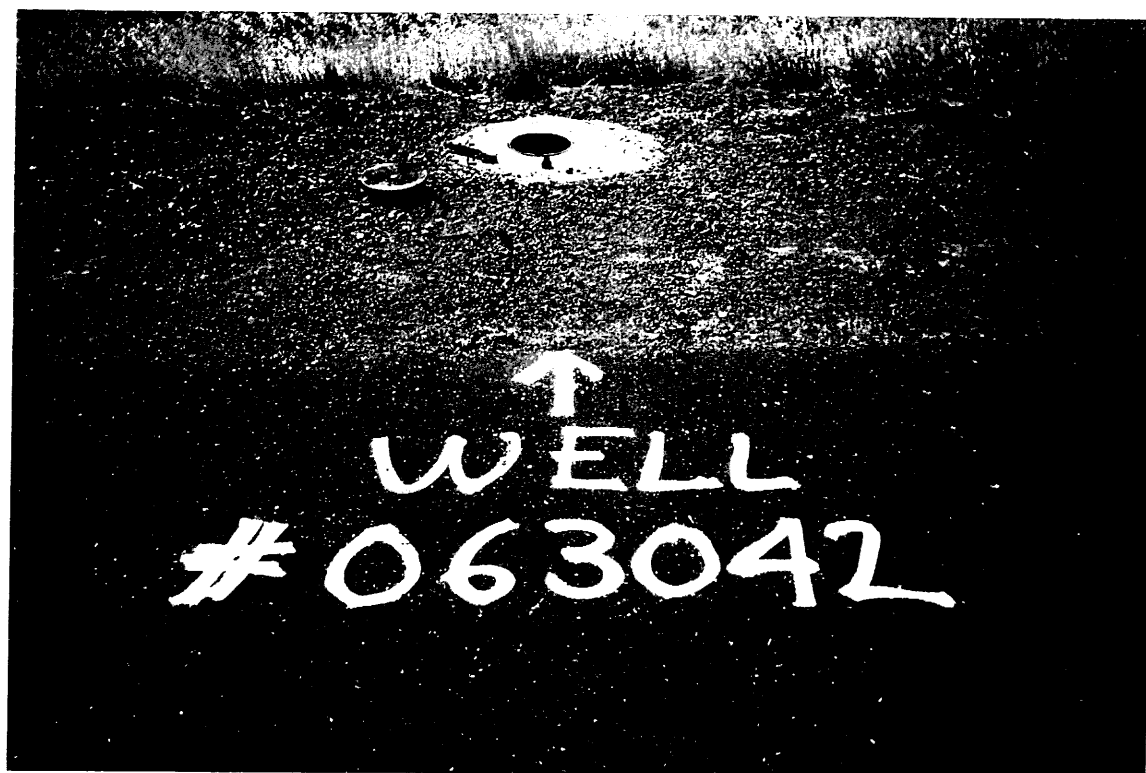
Observation Piezometer.

- The observation well and cap threads were thoroughly cleaned and lubricated (greased) before the well was sealed.
- The air temperature probe and rain gauge were disconnected from the steel pole and the pole was removed from the bottom joint. The pole stub, embedded in the ground, was cleaned and lubricated before capping.
